NASA/TM-2008-215525
NESC-RP-06-61/05-036-E

Failure Analysis Study and Long-Term Reliability of Optical Assemblies with End-Face Damage

**Failure Analysis Study and Long-Term Reliability of Optical
Assemblies with End-Face Damage
Technical Assessment Report**

***Phase I: International Space Station (ISS) Termini Root Cause
Analysis Report***

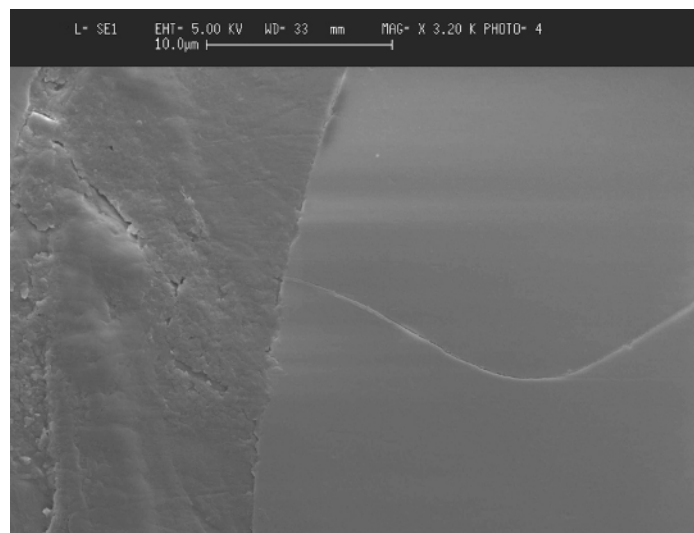
Figure 7.11-3. Magnification of 3.2 KX

The ends of the crack can be clearly analyzed under 3.2×10^3 and 2.8×10^3 X magnifications (Figure 7.11-3), but no definitive origin was identified.

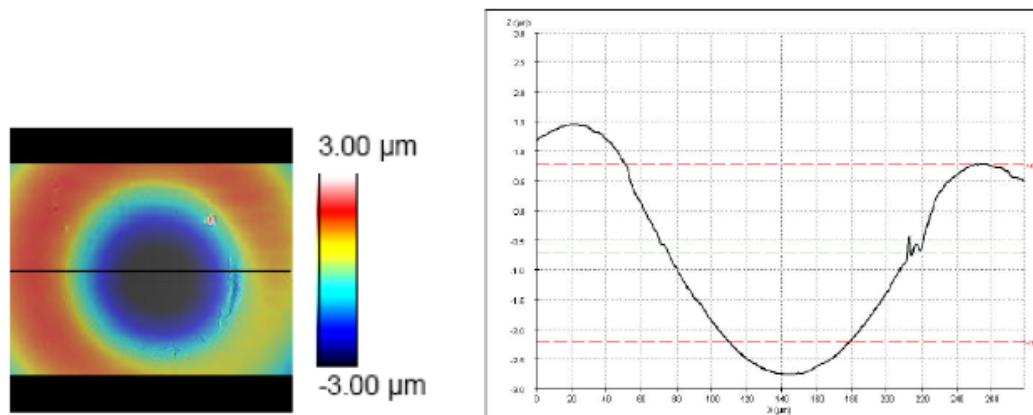
Figure 7.11-5. Profile of End-Face

Confocal data (Figure 7.11-5) indicates the end-face has a concave profile, with a radius of 1.2 mm.

1. The deep scratches in the fiber coating are indication the glass could have been damaged during the polishing or cleaning process.
2. The cleanliness of the termination was not maintained.

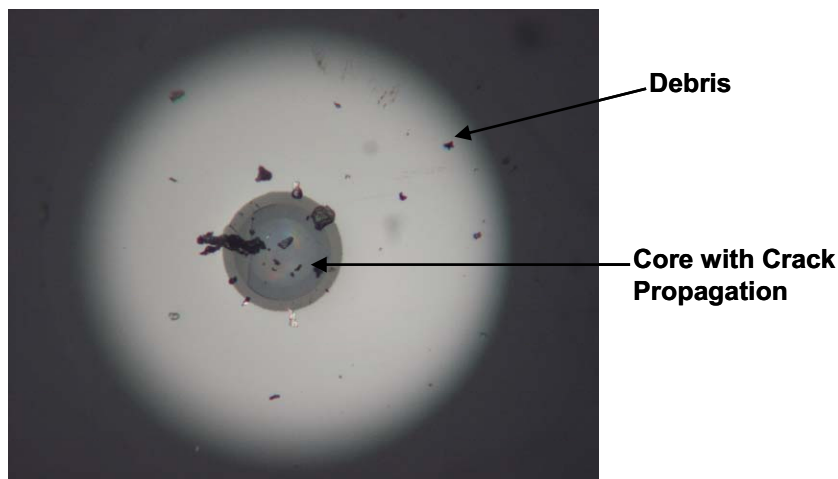
Figure 7.12-1. Connector with Considerable Debris

This terminus has considerable debris (Figure 7.12-1). There is a crack that has propagated through the core, but if the crack did not occur, the optical signal would still be severely diminished due to the amount of debris.

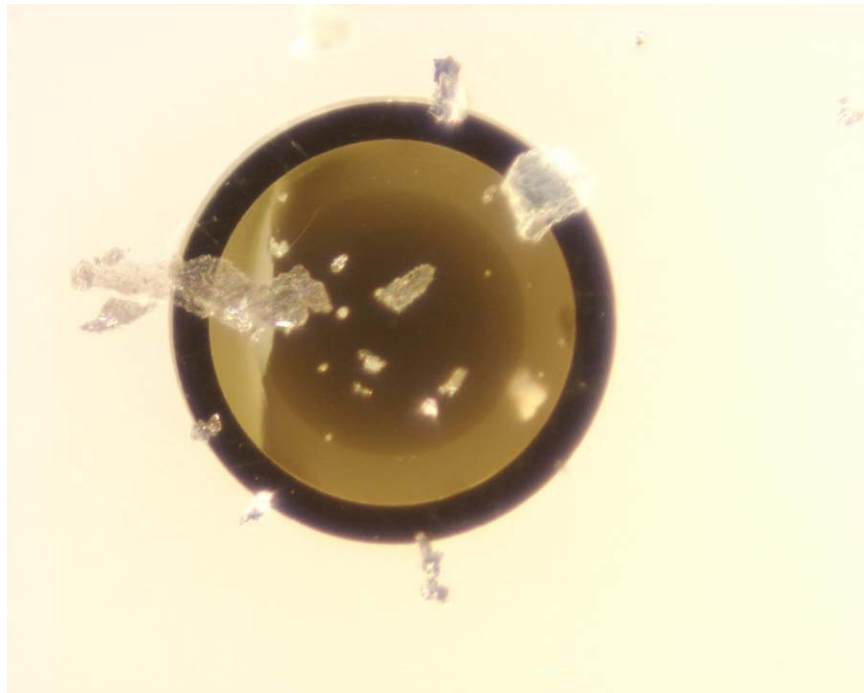
Figure 7.12-2. Magnification of 200X Bright Field Illumination

The crack can easily be observed at a 200X magnification (Figure 7.12-2) and with dark field illumination.

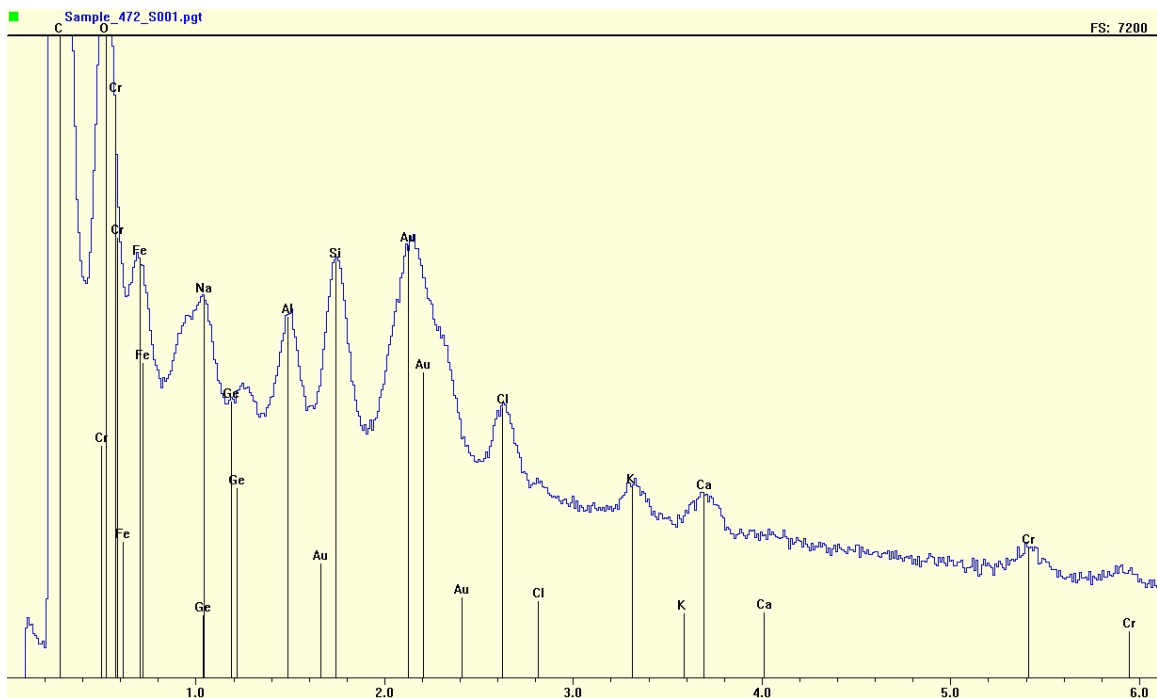
Figure 7.12-3. EDS Data of Debris on End-Face

An EDS data analysis (Figure 7.12-3) of the end-face identifies many foreign elements that make up the debris.

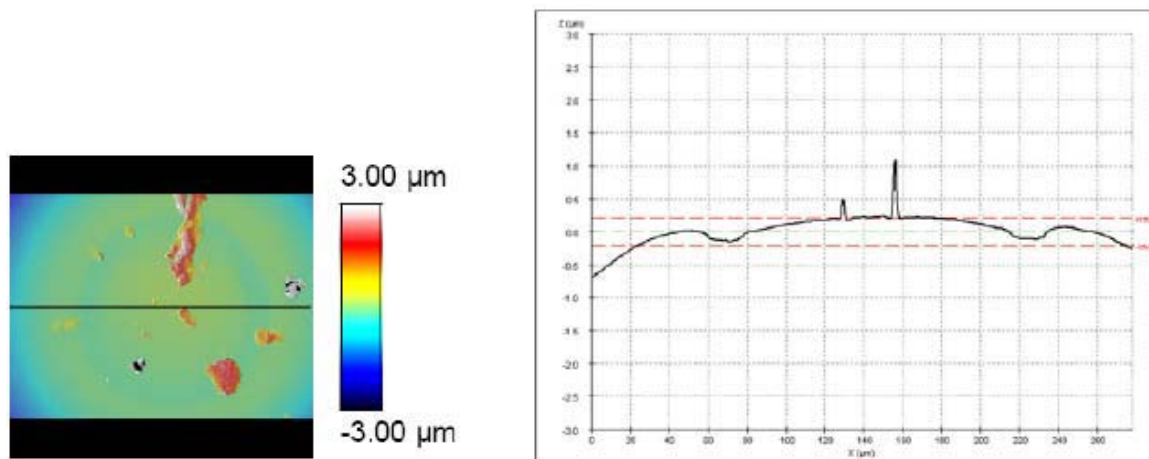
Figure 7.12-4. End-Face Profile

Confocal data (Figure 7.12-4) suggests the end-face has a slight convex profile. However slight it may be, the fiber still extends beyond the ferrule. The radius of curvature measured 8.7 mm. It is important to note the height of the contamination showed in Figure 7.12-4. The large spike in the center of the graph shows the particles height at that location as being well above the surface of the optical fiber terminus. When this terminus is mated to another terminus in close proximity that particle will undoubtedly make contact with both surfaces as it is compressed between the two interfaces. This impact can cause damage to both optical fibers being mated together.

1. The end-face has considerable debris which suggests the glass was damaged due to improper cleaning techniques. Mating unclean connectors can cause damage to fiber optic end-faces.
2. The confocal data suggests the convex fiber end-face extends beyond the ferrule.

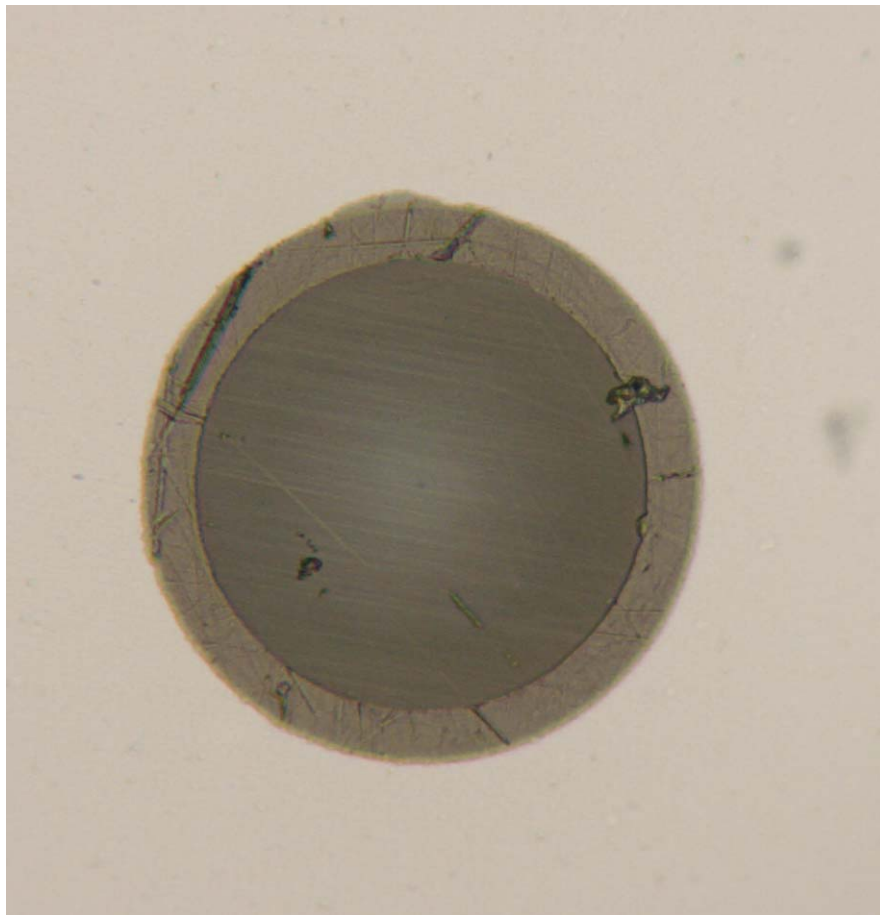
Figure 7.13-1. Deep Scratches from Polishing Process

Deep scratches on the face of the fiber (Figure 7.13-1) are indication that it was ground with the coarse grit, and not followed up with a finer grit lapping film. Scratches to this extent can cause latent cracking.

This sample was compromised before SEM and EDS could be performed. The deep scratches identified using optical microscopy (Figure 7.13-1) indicates the polishing process was not performed per specification.

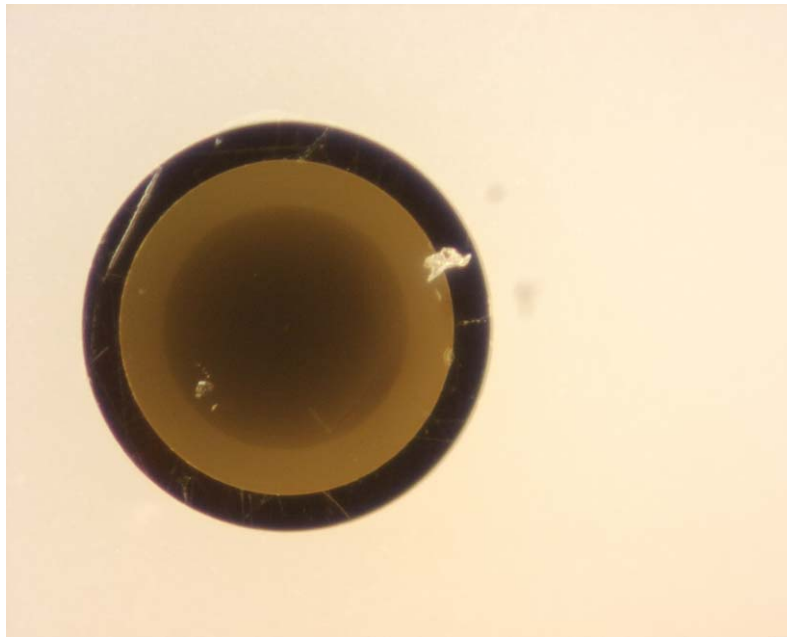
Figure 7.13-2. No Visible Cracks

Despite the scratches from the lapping film, there are no visible cracks in this fiber. However, given enough time, cracks could propagate.

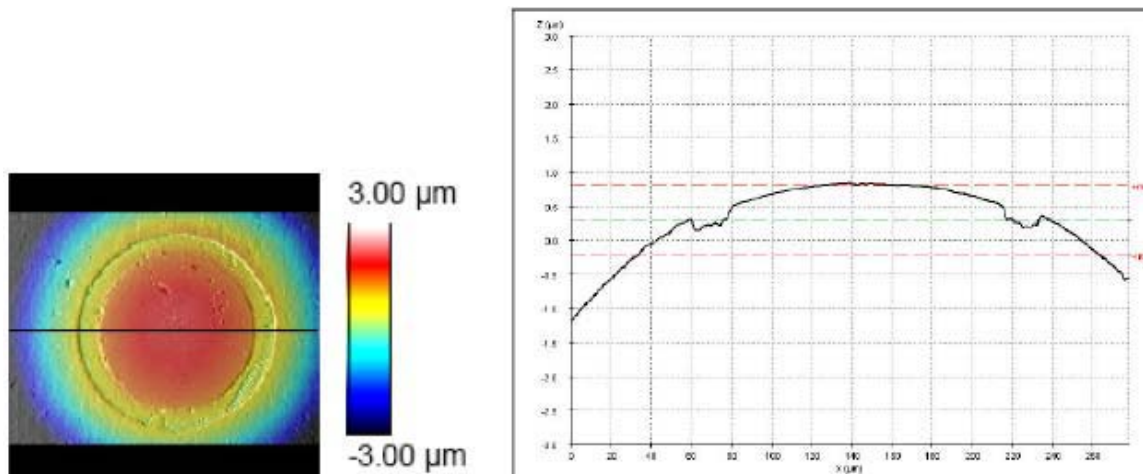
Figure 7.13-3. Confocal Data

Confocal microscopy data (Figure 7.13-3) identifies the profile of the end-face to be convex, with a radius of curvature measuring 7.4 mm.
